Manhole Inspection Summary

Manhole # S09MM1035MH

Location Address: **3620 MANCHESTER AVE**

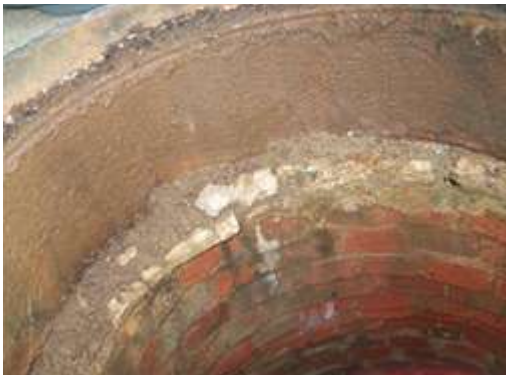
Defect 2

Condition: ☐ Sound ☒ **Cracked** ☒ **Root Intrusion** ☐ Loose Brick ☐ Deteriorated

DETERIORATED CHIMNEY

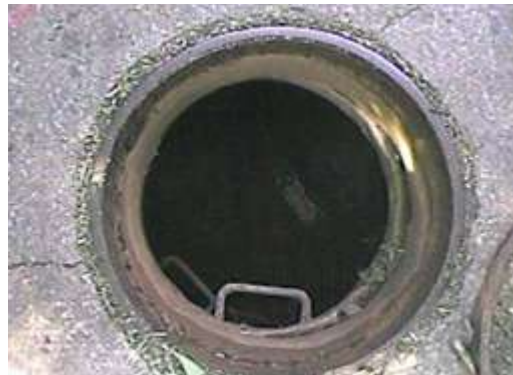
Defect 1

Frame Offset: **1** (in.) Condition: ☒ Sound ☐ Cracked ☐ Leaks

FRAME OFFSET

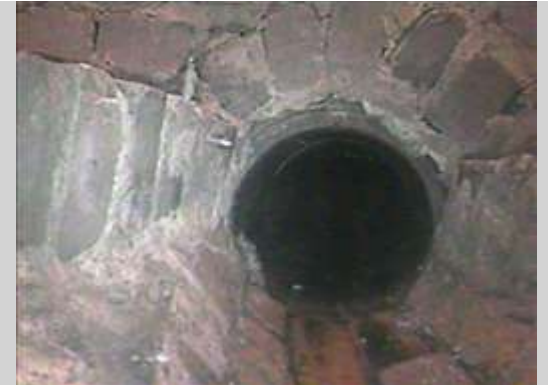
12 O'Clock Outflow

8 in. Circular Gravity Sewer
Pipe Out @ 12 O'Clock

Pipe Height: (in.) Direct
Pipe Material: **Clay** ☐ Pipe Lined
Invert Depth: **6.05** (ft.) Flow Characteristics: **Slow**
Deposits: ☒ None ☐ Mud ☐ ~~Sludgy~~ ☐ Debris ☐ Grease
Silt Depth: (in.) Deposits Extent:
Infiltration: **None** Pipe Seal Cond: **Sound**

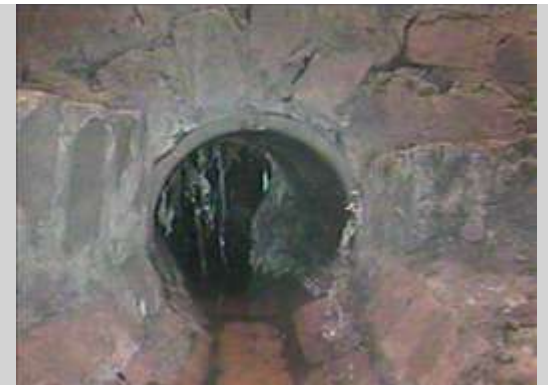
4 O'Clock Inflow

8 in. Circular Gravity Sewer
Pipe In @ 4 O'Clock

DETERIORATED CHIMNEY

Pipe Height: (in.) Direct
Pipe Material: **Clay** ☐ Pipe Lined
Invert Depth: **5.90** (ft.) Flow Characteristics: **Slow**
Deposits: ☐ None ☐ Mud ☒ ~~Sludgy~~ ☒ Debris ☒ Grease
Silt Depth: **0** (in.) Deposits Extent: **Medium**
Infiltration: **None** Pipe Seal Cond: **Sound**
